WINTER OPERATION AND MAINTENANCE OF TUNNELS IN NORTHEASTERN MINNESOTA

*Duane Hill, Assistant District Engineer,
Operations; Minnesota Department of Transportation, District One*
duane.hill@dot.state.mn.us

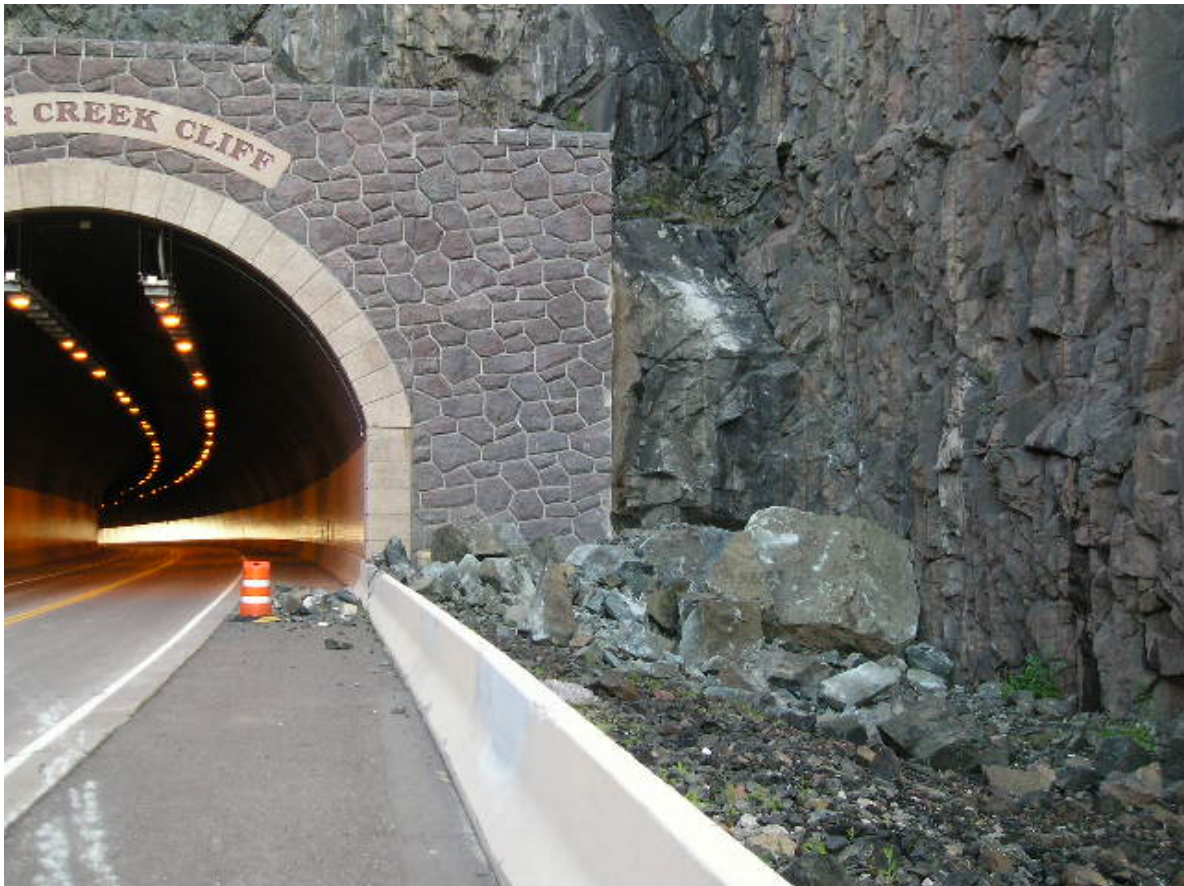
A third winter maintenance issue relates to the portals of the hard rock tunnels that are located along T.H. 61. The Silver Creek Cliff Tunnel has portals cut into hard rock (Figure 2). The resulting faces of the tunnel portals have vertical rock faces up to 120 m high that run parallel and perpendicular to the roadway. Below these rock faces, are engineered rock catchments ditches that were designed to trap any falling rock and debris from the portal faces and prevent the falling rock from bouncing or landing on the roadway. The rock catchments ditches were designed to include a width of up to 12 m wide, and a depth varying from 1.2 m to 2.4 m. The dimensions vary depending upon the height of the adjacent rock face. All of these rock catchments ditches have a concrete traffic barrier located between the roadway surface and the ditch (Figure 2).

Figure 2. Rock Fall debris at Silver Creek Cliff Tunnel on Minnesota Trunk Highway

The exposed rock face of these tunnel portals is weathering at a rate much greater than anticipated. This has resulted in seasonal rock fall occurrences which tend to be greatest in the spring as melt water freezes and thaws more frequently. These rock fall occurrences also seem to be accelerated during rainy periods. Some of these rock fall occurrences have been small. Resulting rock fall varies from a few small rocks to piles of up to a few cubic meters. More recently, the rock falls have become larger, resulting in the catchment ditches becoming filled and some rock bounding off the resulting rock pile in the ditch and onto the roadway. This is not an acceptable condition due to the impact that rock falling or laying on the roadway could have on traffic safety. The initial rock falls have been addressed by taking immediate action to clean the rock catchments area. As the problem has become more severe at the south portal, it was determined that the rock catchments area was not of adequate size and that the portal face has weathered to the extent that additional techniques would be needed to remove rock in a controlled manner rather than allowing it to fall under the forces of mother nature.

A process was developed to map the weathered areas and identify those that were most in need of removal by our staff geologists. The geologists determined that some of the failure planes in the rock face created conditions where masses of rock were susceptible to failure. A contract was let to scale these areas. A variety of techniques were discussed and employed. Due to difficulty in access to the nearly vertical rock face, hand scaling is not a feasible option. The initial scaling attempt consisted of drilling and blasting. Access for drilling required that workers access the rock face from a man basket lifted by a hydraulic crane. Drilling for placement of the blast charges was accomplished using handheld drills. This method proved to be very time consuming and inefficient. The workers were subject to the danger of disturbed material falling on them while they were drilling holes for the next charge.

Another method was employed using a mobile crane with a cable lift assembly and wrecking ball to mechanically remove the hazardous rock outcroppings up to 30 m high. This method was found to be very efficient due to the fact that any material that was not solid could be removed within a few impacts with the wrecking ball. This method also allowed all workers to be out of harms way during the removal process.

The next step in this process was to completely clean out the rock catchment area to ensure that it had the maximum capacity available. The rock catchment ditch area was increased by creating a 2 m high wall made of rock-filled gabion baskets on the back side of the concrete traffic barrier to increase the depth of the catchment ditch. The permanent solution will be to replace the concrete traffic barrier with a structural wall that is 2 m high and has a sacrificial timber back to prevent damage to the concrete from falling rock.
