EFFORTS TO IMPROVE THE VISUAL ENVIRONMENT ON EXPRESSWAYS THAT PASS THROUGH AREAS OF SNOWSTORM AND DRIFTING SNOW

K. Abe
NEXCO MAINTENANCE TOHOKU Co., Ltd., Miyagi, JAPAN
k.abe.ac@e-nexco.co.jp

ABSTRACT

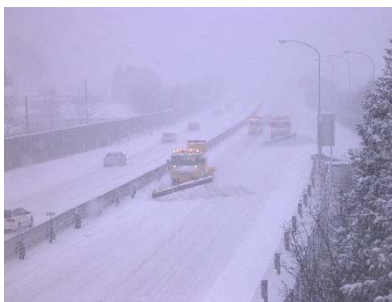
Ordinary snow removal operations are carried out in a formation comprising 2 or 3 snow removers followed by a traffic sign vehicle guarding the rear of the formation. (Pic. 1)

<Pic.1- Snow removal operations >

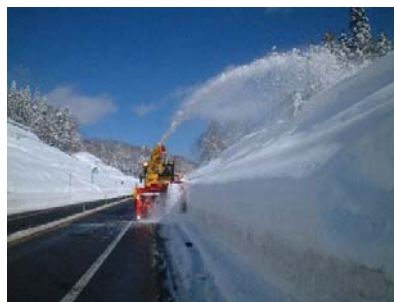
As the bank of snow formed when the plough of the snow remover pushes snow onto the shoulder of the road grows larger, snowbreak fences and visual guidance facilities become buried in the snow, obstructing visual guidance to drivers and, depending on the circumstances, causing them to lose sight of the direction in which they should be traveling. Thus in between snow removal operations rotary snow ploughs are used to throw the banks of snow piled on the shoulder clear of the road, combined with human muscle power used to uncover visual guidance facilities; but this is not necessarily satisfactory. (Pic 2)

<Pic.2- Removal of snow bank by rotary snow plough >

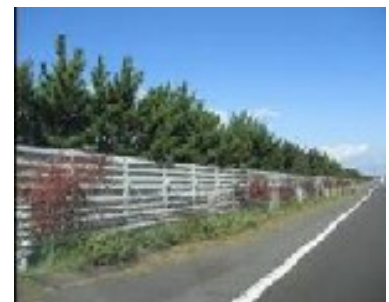
<Pic.3- Snowdrift prevention forest and snowbreak fence >

The total length of snow drift prevention forest that has grown to a height of 5 m and higher (Japanese cedar trees, Norway spruce, Sakhalin fir, etc) has reached some 135 km (as of the end of 2007). However, the inability to secure a wide enough strip of land for planting limits the effect of the snow drift prevention forests, and generally snowbreak fences to a height 3 to 5m higher than the road surface are erected along the top of the shoulder slope. (Pic 3)

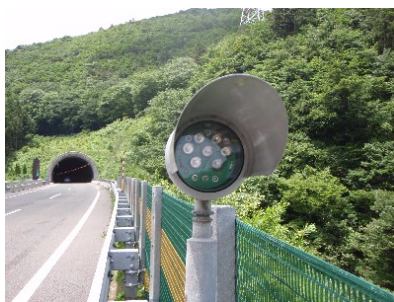
<Pic.5 -LED>

Convex mirror-type delineators are erected on expressways as standard visual guidance facilities. In addition to these, self-luminous delineators (visual guidance lights with a light-emitting source) have been erected in areas where impaired visibility is a frequent occurrence. In the past incandescent lamps were used, but in recent years an LED (light emitting diode) system is used. (Pic 4, Pic 5). So that these self-luminous lights can promote visual guidance, a system is adopted whereby they flash on and off in unison on continuous stretches of road. In the case of an LED system, the maximum luminosity is in excess of 30cd. The self-luminous delineators take their power from the power lines, and have been erected along some 300 km of road (As of March 2008). At roughly 90,000 yen per light (installation cost + material cost), these lights are expensive.

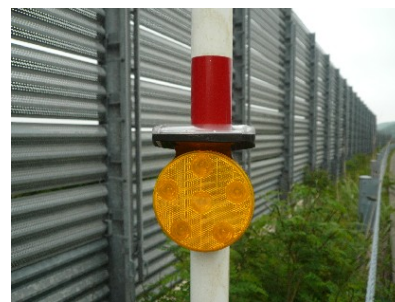
In 2006 solar cell LED lights, which can be erected easily, needing no power cables and each costing roughly one-tenth the cost of an electrically-powered light, were adopted on a trial basis. (Pic 6) The solar cell self-luminous delineators do not match ordinary electrically-powered lights in terms of the brightness of the light they emit, but they are very serviceable in that they can be set up simply by being fixed by a metal band to existing snow poles at a height of 2 m.

< Pic.6-
Solar cell-powered LED >

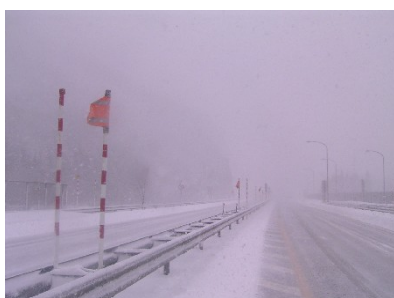
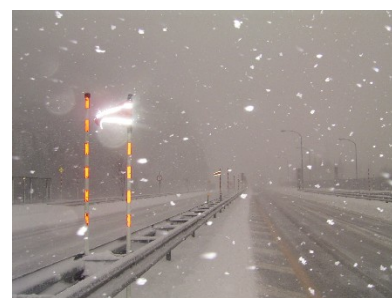
Roadside delineators suffer loss of function if snow adheres to their luminous surface, and so a flag with a reflector attached was designed. The flag can be fixed to the uppermost part of an existing snow pole; in addition to the flag itself providing visual guidance to drivers as it flutters, by fluttering it can prevent snow sticking to the snow pole. During the winter the flags are set up at intervals of 50m at a height of 2.8m above the road surface on the shoulder and on both sides of the median strip, to clearly indicate both sides of the roadway. (Pic 7)(Pic.8)(Pic.9)

< Pic.7-
Visual guidance flags >

< Pic.8-Installation >

< Pic.9-
Reflection Camera flash) >

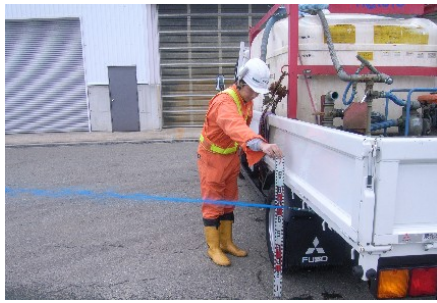
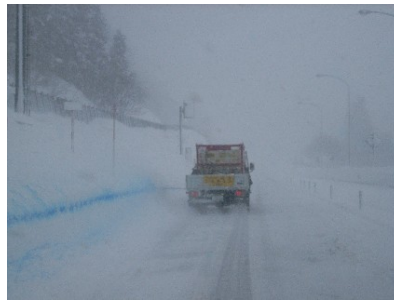
The Blue Line is sprayed onto the snow bank from spraying equipment (power sprayer + water tank) mounted on a 2t truck. The 2t truck runs at a distance of approximately 1.5 m from the snow bank and the blue-pigmented liquid is sprayed from a nozzle fitted to the lower part of the bed of the truck. The liquid is sprayed a distance of 1.5 m and spreads out to color the snow bank with a band about 30 to 40 cm wide. The angle of spray is adjusted so that the top edge of the Blue Line is roughly 1.0m from the surface of the road, which is equivalent to the position of the guard rail. (Pic.10)(Pic.11)(Pic.12)

< Pic.10-
Spraying equipment >

< Pic.11-
Spraying the Blue Line >

< Pic.12-
The Blue Line after spraying >

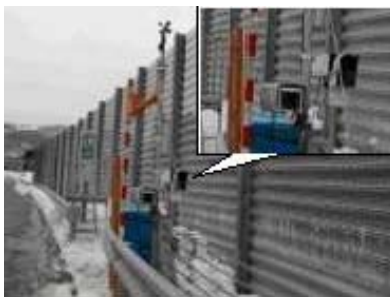
A fixed CCD camera was set up on the outside of the snowbreak fence at 13KP on the Akita Expressway (on the eastern side of the Ohu mountain chain), where visibility is frequently impaired due to snow storms. The CCD camera was set up at a height of 1.2 m from the road surface, this being estimated to be the viewpoint from an ordinary motorcar. Together with the video capture, visibility was measured using a backward-scatter visibility meter. (Pic.13)

< Pic.13-
Observation equipment
in position >

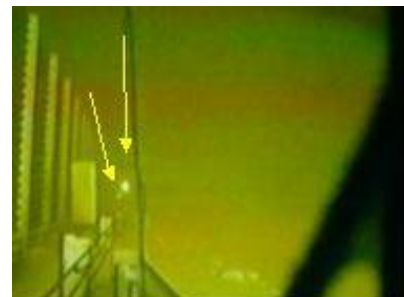
< Pic.14- Good visibility >

< Pic.15- Poor visibility >

The observation point is located on a R=1,000m curve to the right, and as can be seen in Pic 14, when there is good visibility of 350m 10 electrically-powered delineators (to a distance of 337 linear meters from the camera) can be ascertained, and it is possible to make out the curvature of the road alignment. However, when a snow storm reduces the visual field to a rather poor 48 m, it is possible to make out only 2 of the electrically-powered delineators. (Pic.15)
