HIGH-SPEED PLOUGH/ENVIRONMENTAL PLOUGH

P. Gruhs

National Swedish Road Administration, Borlänge, Sweden
pontus.gruhs@vv.se

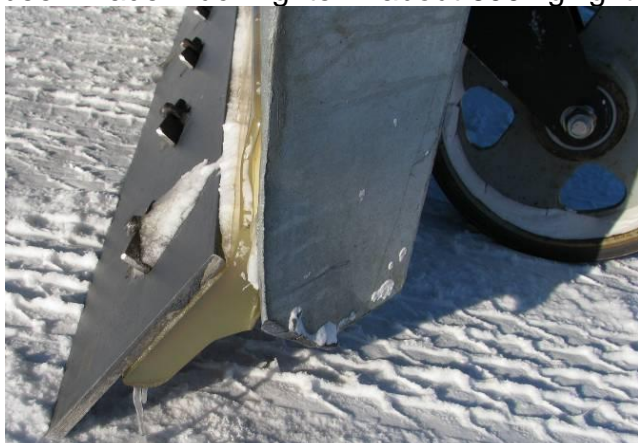
Figure 1 – The flexible cutting edge mounts and the environmental plough attached to a lorry.

That which is new with this new type of plough is that it has flexible mounts for cutting edges and better supporting wheels. Both components are made of polyurethane, which has entailed that the ploughs can move forward at much higher speeds than what is normally the case. Because the plough lacks spring dampers, among other things, it has been made much lighter – about 600 kg lighter than a conventional plough.

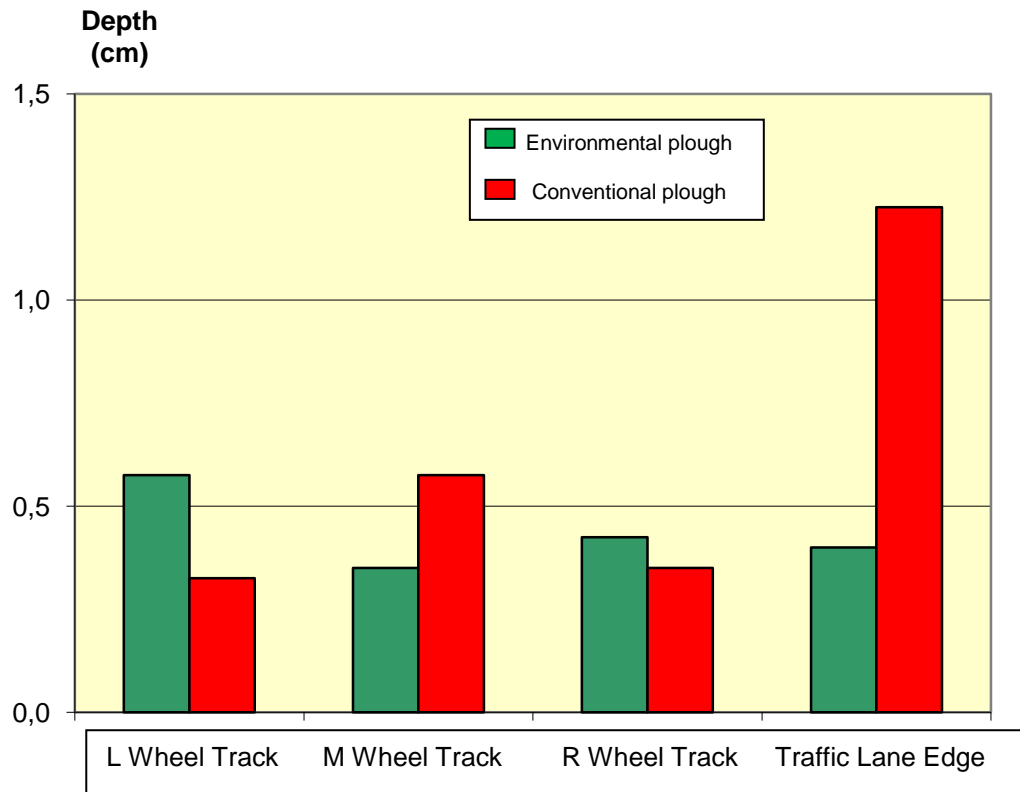
Full snow removal performance at 30 km/h

Figure 3 – Full snow removal performance. The average values for snow depth after 4 ploughings at 30 km/h

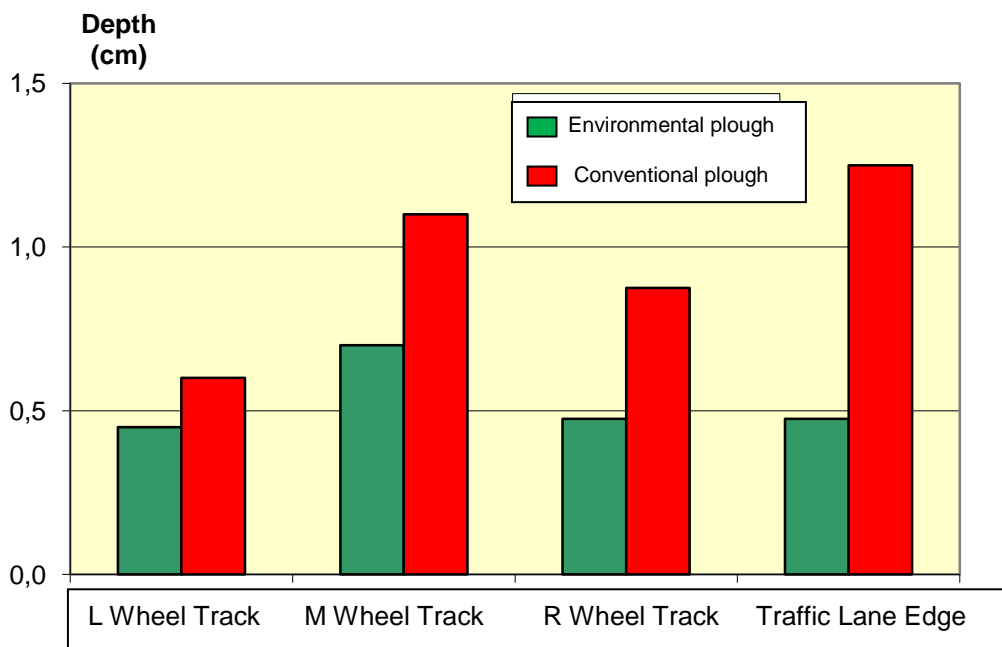
Full snow removal performance at 70 km/h

Figure 4 – Full snow removal performance. The average values for snow depth after 4 ploughings at 70 km/h

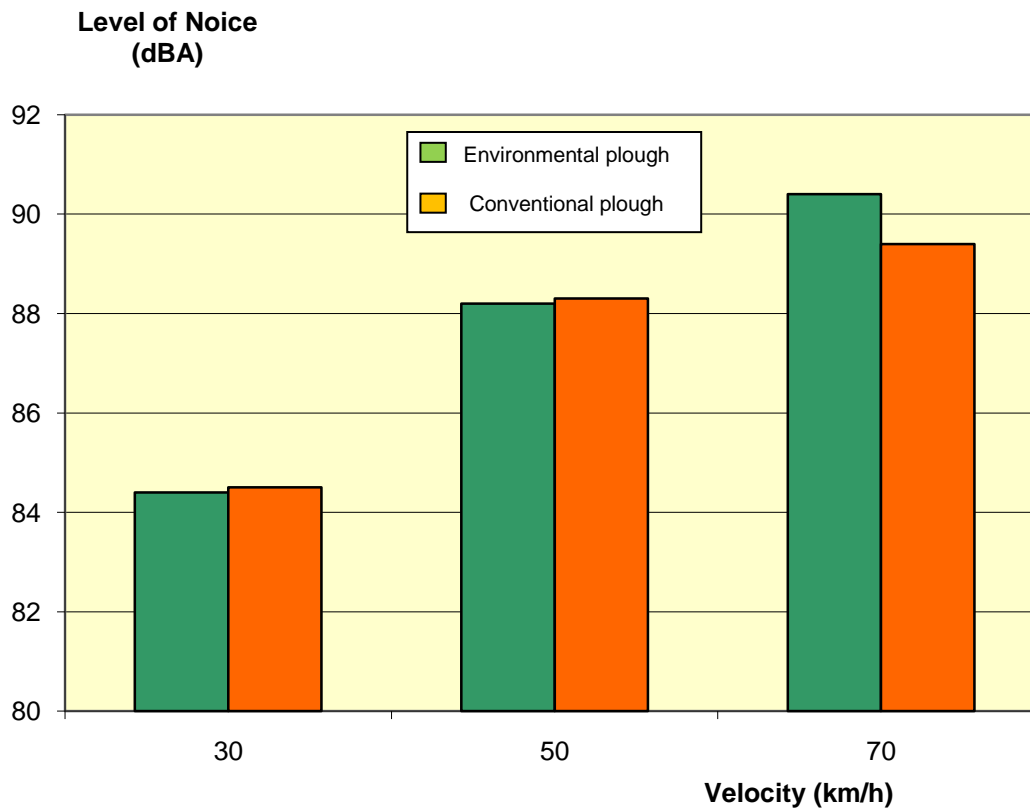
Noise measurements, Hedlanda airport

Figure 5 – Noise levels measured on airfield. Average values of three passes and two directions. The road surface was coated with a thick layer of ice with a thin layer of packed snow in patches.

As seen, the difference between the two different ploughs is insignificant, with a maximum of 1 dBA.

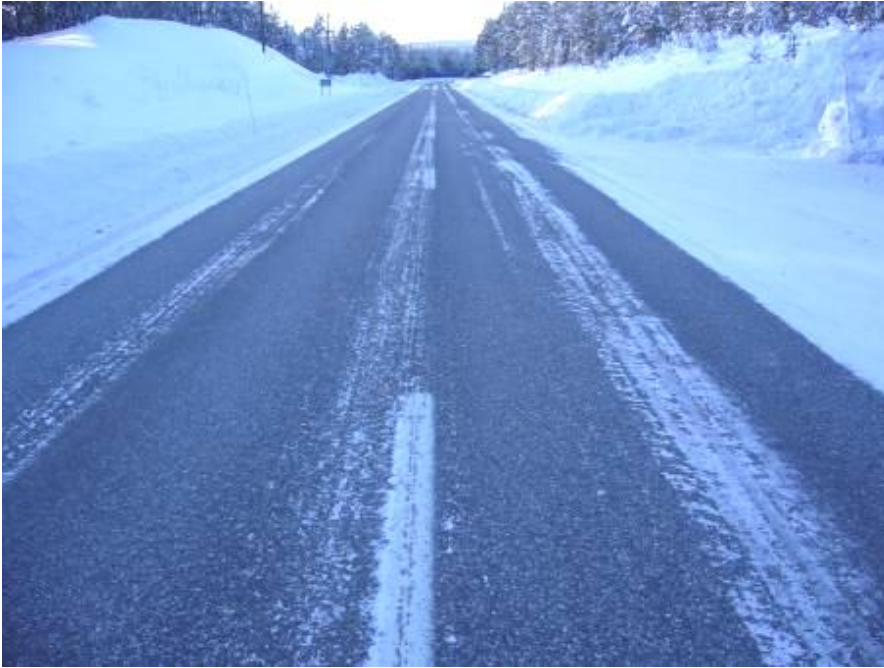
Figure 6 – Road surface on highway 84 during measurement.

During noise measurement on a normal road the surface was snowless with small strips of packed snow according to figure 6.

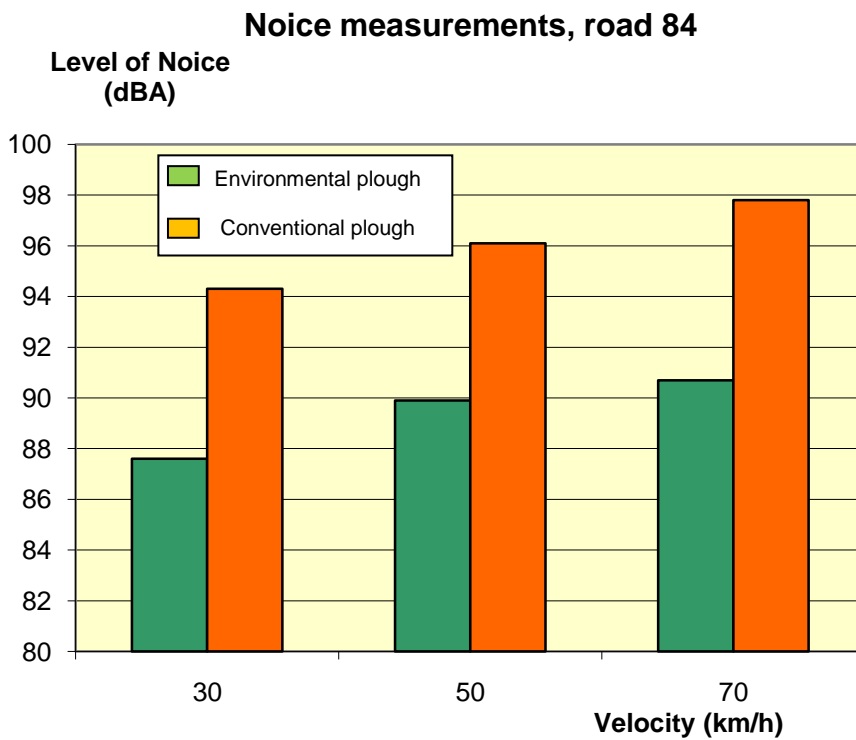
Figure 7 – Noise levels measured on highway 84. Average values of one pass in each direction for each speed. The road surface was snowless with small strips of packed snow.

The difference between the two different ploughs is significant for these measurements. The environmental plough has a 6–7 dBA lower noise level.

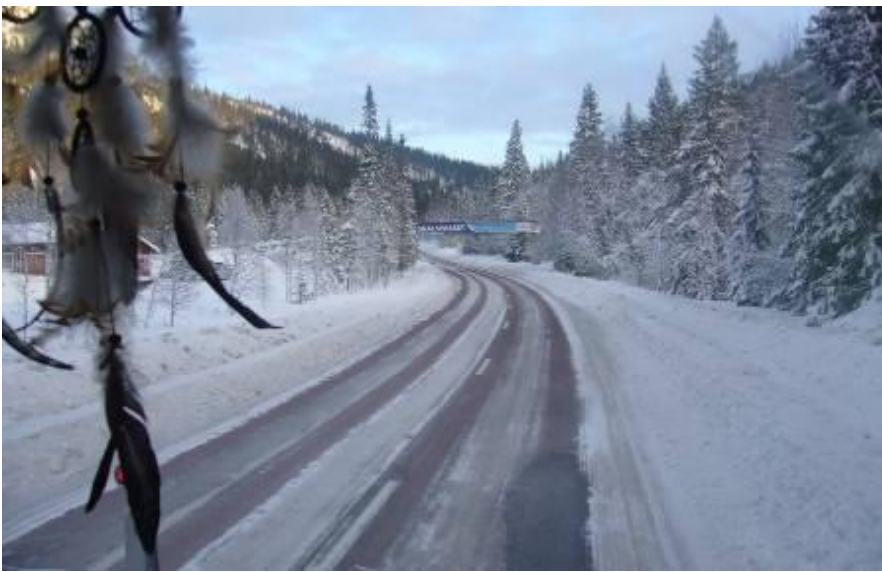
Figure 8 – Road surface on highway 315 during fuel consumption measurement.

The road surface during measurement was rutted with no snow in the wheel tracks but with packed snow beyond according to Figure 8.

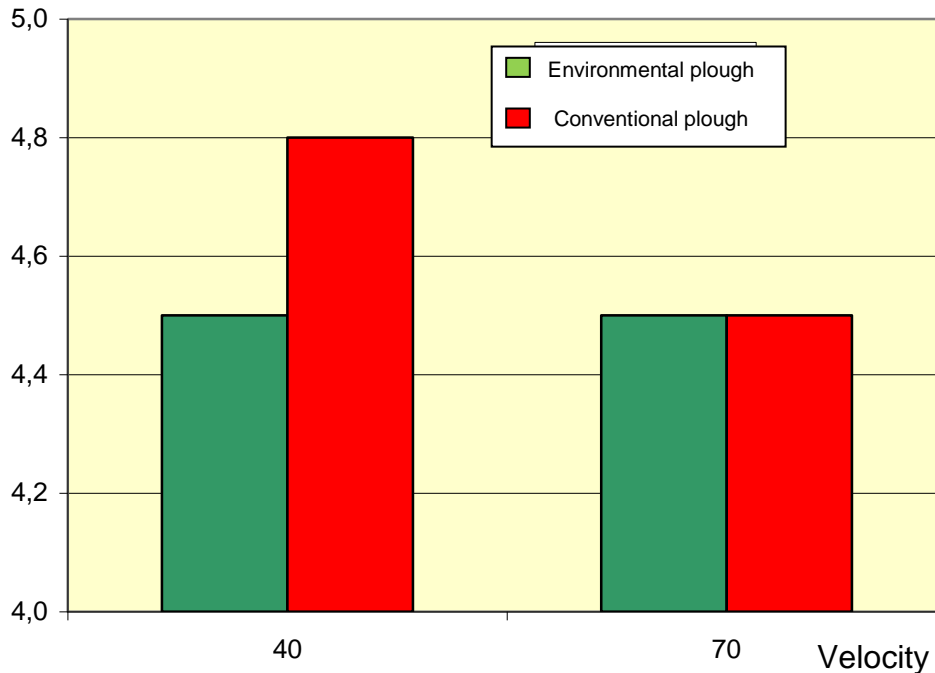
Fuel consumption when driving on highway 315

Figure 9 – Measured fuel consumption after 44 km on highway 315. The road surface was rutted with no snow in the wheel tracks but with packed snow beyond.

After having driven about one-third of the first round at 40km/h with the environmental plough and having managed the steep uphill grades, the plough vehicle driver observed that fuel consumption to this point was at about 1 litre per 10 km lower than when the same stretch was driven with the reference plough. This gives an indication that the fuel consumption for the environmental plough may have been substantially overestimated due to the failures.

Wear of cutting edges is calculated by measuring the distance on each of the four cutting edges between the lower mounting holes and the cutting edge's lower edge before and after the plough vehicle has driven both loops, i.e. a distance of almost 2 times 44 km = 87 km. See Figure 9.

As can be seen in Figure 9, average wear on the environmental plough's cutting edges 1 and 2 (those closest to the edge of the roadway) was insignificant. Wear on cutting edge nos. 3 and 4 was significantly higher, about 3–4 mm after two rounds. Wear on the reference plough's cutting edges averaged between 3 and 8 mm after two rounds.
