RESEARCH ON ENVIRONMENTAL IMPACT OF SPREAD DE-ICING SALTS

Y. Yamamoto, S. Sone, K. Kimura, Y. Namikawa
National Institute for Land and Infrastructure Management
Ministry of Land, Infrastructure, Transport and Tourism
1, Asahi, Tsukuba City, Ibaraki Prefecture, Japan
do-kan@nilim.go.jp

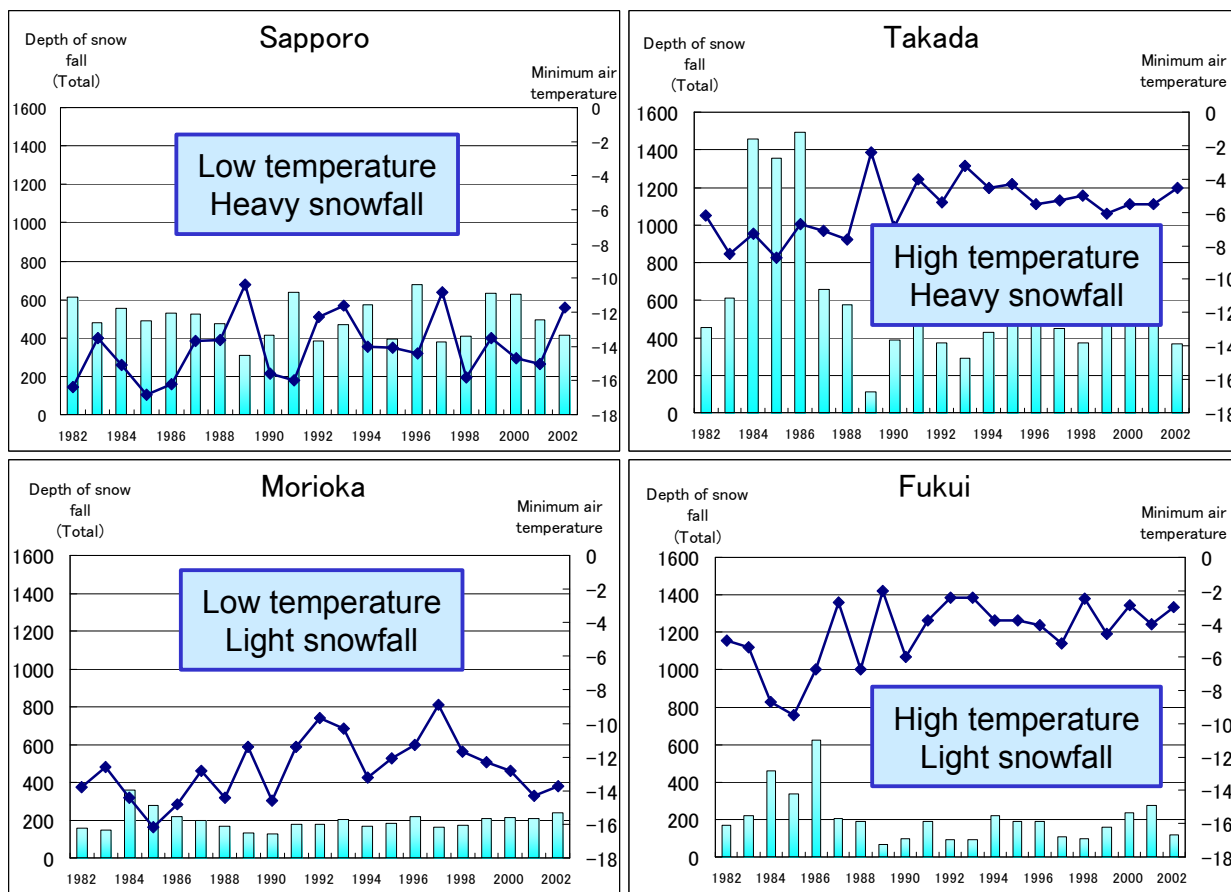
Figure 2 - Temperature and Snowfall by year

60% of the area in Japan is in snowy regions (Figure 1). In these areas, as shown by Figure 2, there is a lot of precipitation but the temperature is not very cold. To guarantee road traffic and ensure safety, road administrations must spread de-icing salts on roads when snow has accumulated in snowy regions. The quantity of spread de-icing salts has tended to grow steadily since studded tires became prohibited. However, it is feared that de-icing salts harm the environments surrounding roads. Therefore, the environmental

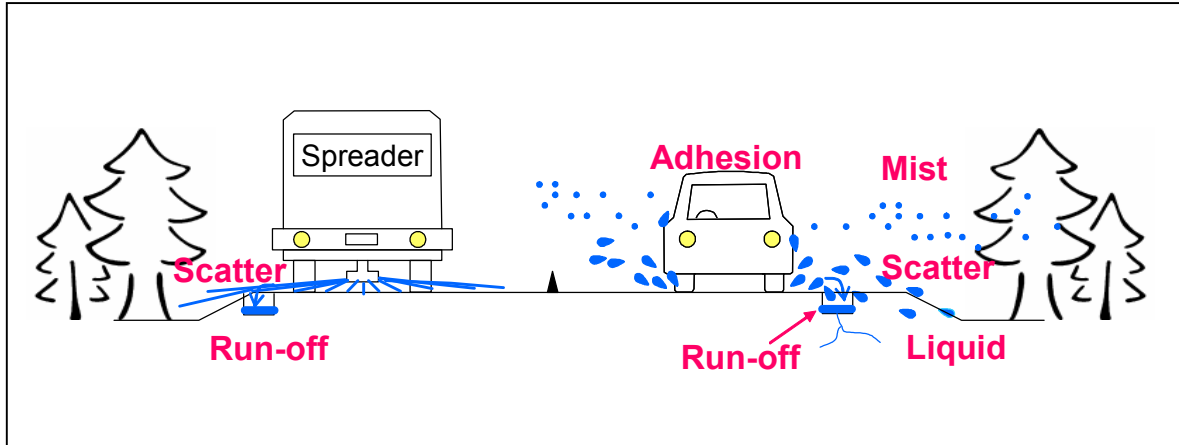
Figure 3 - Patterns of Scattering and Run Off De-icing Salts

As shown in Figure 3, there are four main patterns in which spread de-icing salts scatter and run off from roads. This clarifies the status of scattering and run off of de-icing salts that have been spread on road surfaces in winter.

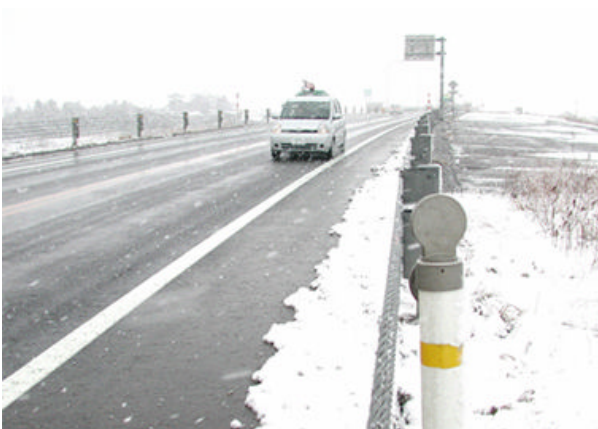
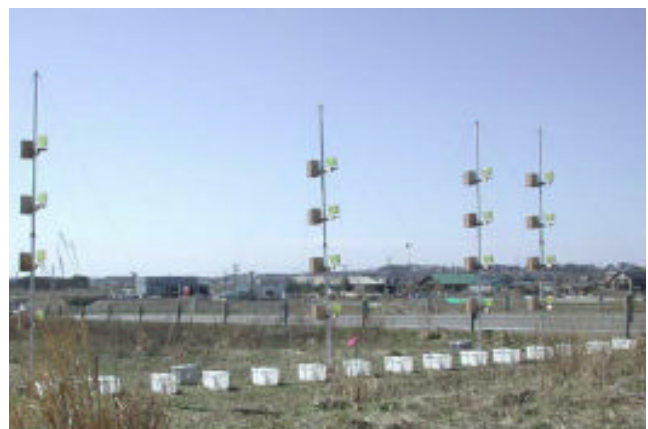
1) The Survey Site

Figure 4 - Photograph of the Survey (Niigata)

Figure 4 shows the survey location (Niigata shown in Figure 1). The de-icing salt was solid NaCl that was spread from a de-icing salt spreading vehicle near the survey location. The de-icing salt spreading vehicle spread 20g/m^2 or 30g/m^2 solid NaCl each time. A total of $2,400\text{g/m}^2$ of NaCl de-icing salt was spread during the survey period.

We gathered the scattered de-icing salts by using vessels and gauzes downwind of the road (Figure 4-2)). The background value for comparison was also gathered windward of the road. The quantity scattered outside the roadway tended to decline as distance from the edge of the road shoulder increased from 0m as shown in Figure 5-1). Of the scattered salts, 72.5% were deposited from the area between the road edge to 3 meters away.

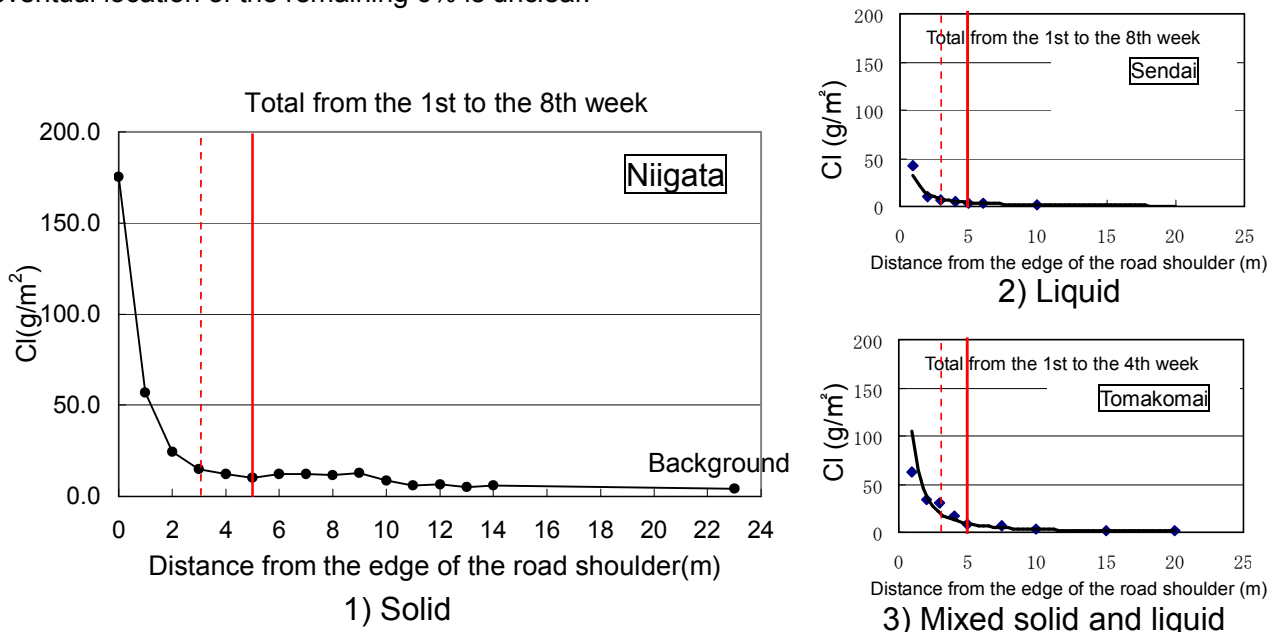
Figure 5 - Quantities of De-icing Salts Scattered Outside the Roadway

There are three patterns in which de-icing salts spread: 1) solid, 2) liquid, and 3) mixed solid and liquid. Currently, in Japan, mixed solid and liquid is the major pattern. As this method has excellent adhesiveness, the quantity of salt scattered outside the roadway is less than the above example using the solid method. (Show other sites results in Figure 5-2)&3))

Figure 12 shows the number and rate of trees with defective growth and their distance from the road edge. The quantities of salt scattered outside the road (Figure 5) and the rate of trees with defective growth (Figure 12) have the same tendency. Defective growth was not observed in area further than 5 meters of road edge because the quantity of salts scattered is low. As such, there is almost no impact on tree growth in areas further than 5 meters away from the road edge.

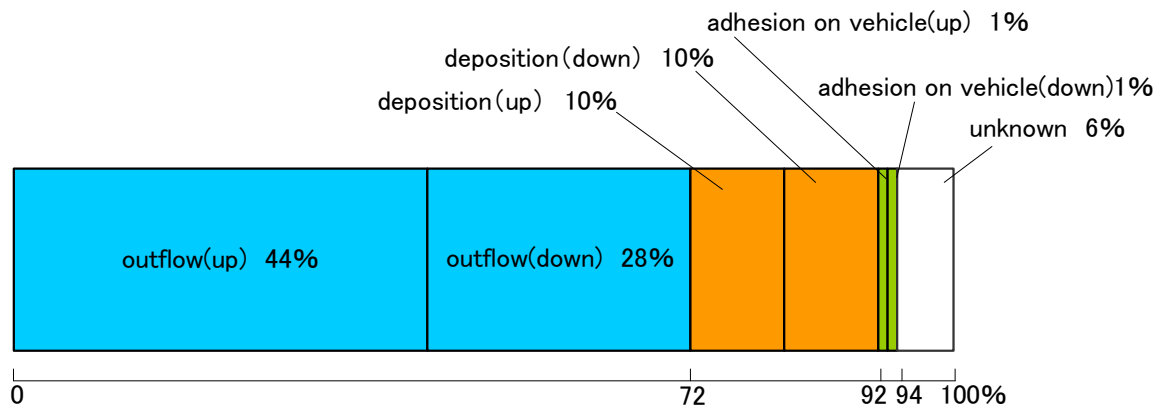
Figure 6 - Material Balance of De-icing Salts

As shown by Figure 6, in terms of material balance, of the total of 656kg of de-icing salt (converted to Cl) spread in the inbound and outbound lanes in the material balance calculation section during the 8 week survey period, 72% was run off, 20% was deposited, 2% adhered to motor vehicles, and the eventual location of the remaining 6% is unclear.

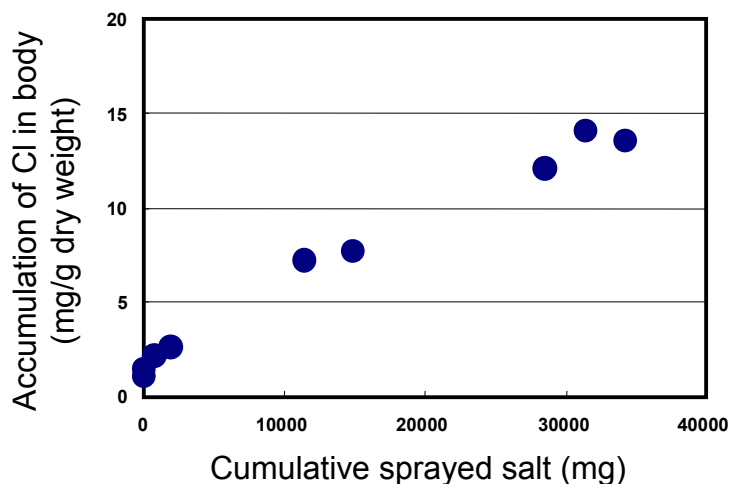
Figure 10 - Example of the Relationship of Quantity of Salt Spread and the Quantity of Salt within the Vegetation

The experiments were done by spraying the subjects indoors with a saline solution three times a day (approx. 50ml/projected area (m²)) for one month or three months to calculate the adhesion and penetration rates. At the same time, component analysis was conducted on the leaves. The results showed that there was a correlation between the quantity of saline spray and the salinity of the bodies of the leaves (Figure 10), and it was confirmed that if the salinity of the leaves exceeded a fixed value, there was a tendency for damage to occur more easily (Table 1).

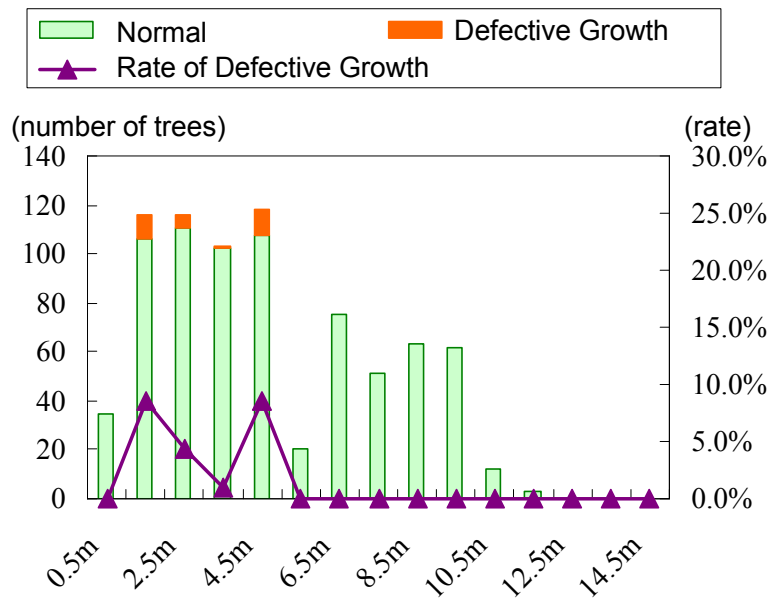
Figure 12 - Number and Rate of Trees with Defective Growth (including distance from the road edge)
