XIII  
INTERNATIONAL  
WINTER ROAD  
CONGRESS

# SUSTAINABLE WINTER SERVICE FOR ROAD USERS

*RESEARCH ON ENVIRONMENTAL IMPACT  
OF SPREAD DE-ICING SALTS*

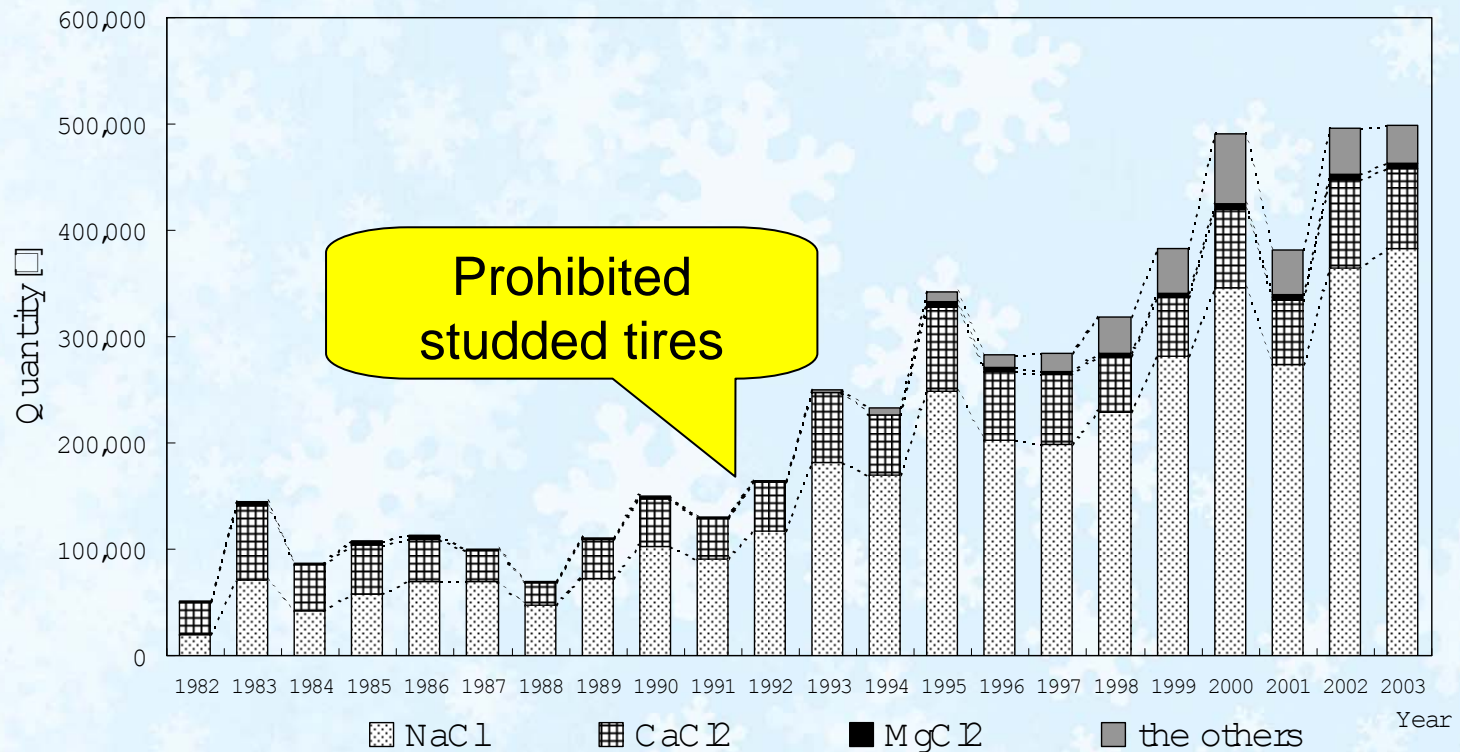
- The quantity of de-icing salts has increased every year since the use of studded tires was prohibited in 1993.

Quantity of de-icing salts in recent years

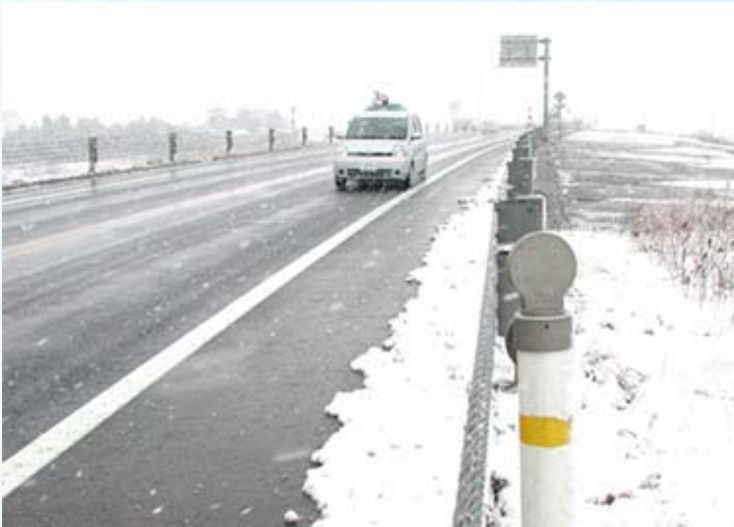
Survey location

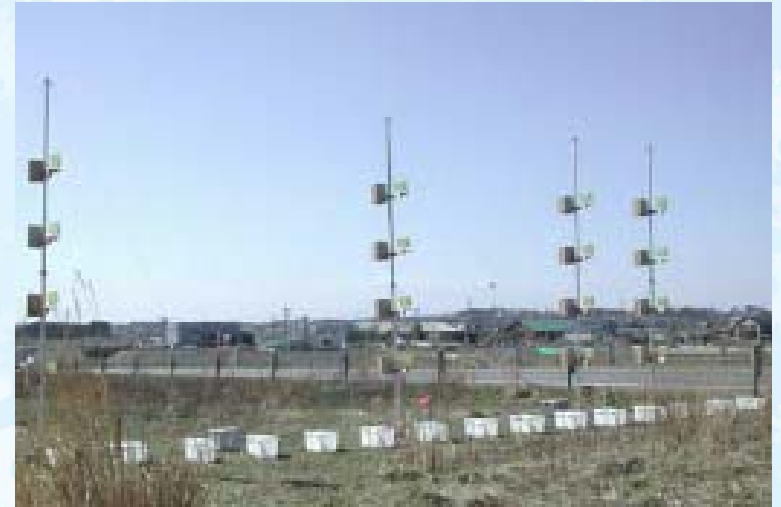
Tools of the survey

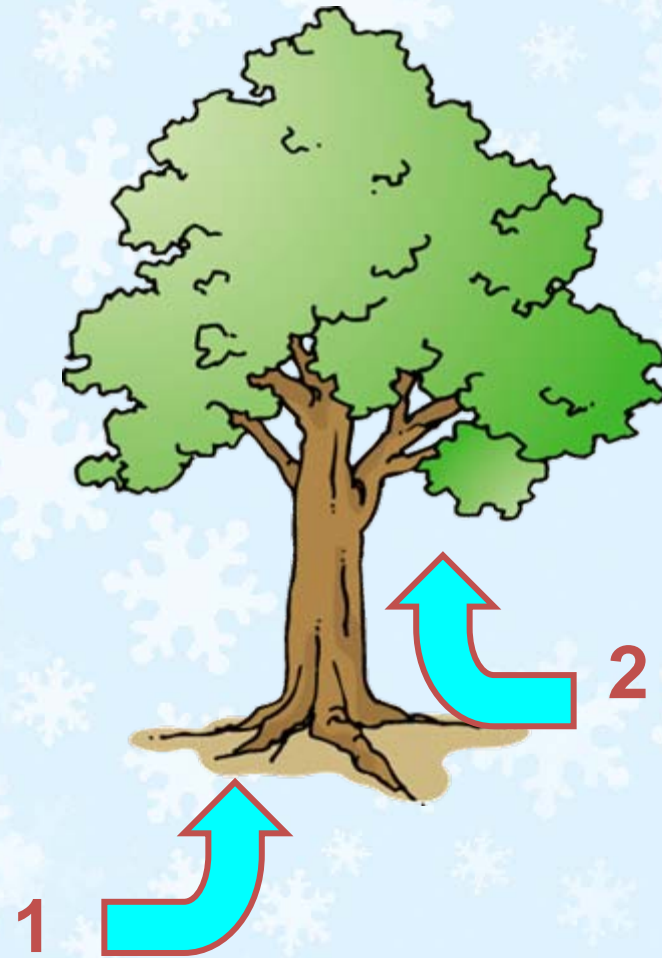
## 4.1 Vegetation Impact Process

1. The absorption of de-icing salts deposited in soil.
2. The penetration of to vegetation de-icing salts.

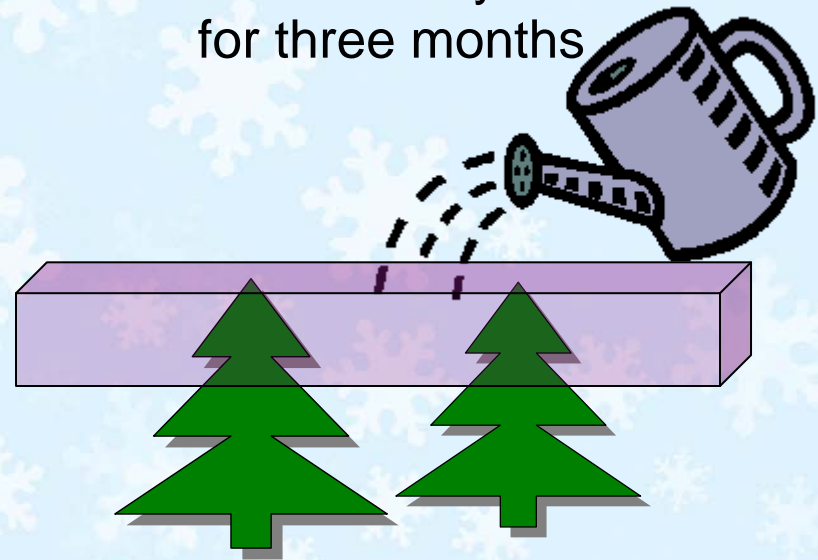
0.05%-8% ,50ml/m<sup>2</sup>  
3times a day  
for three months

Spraying saline in house

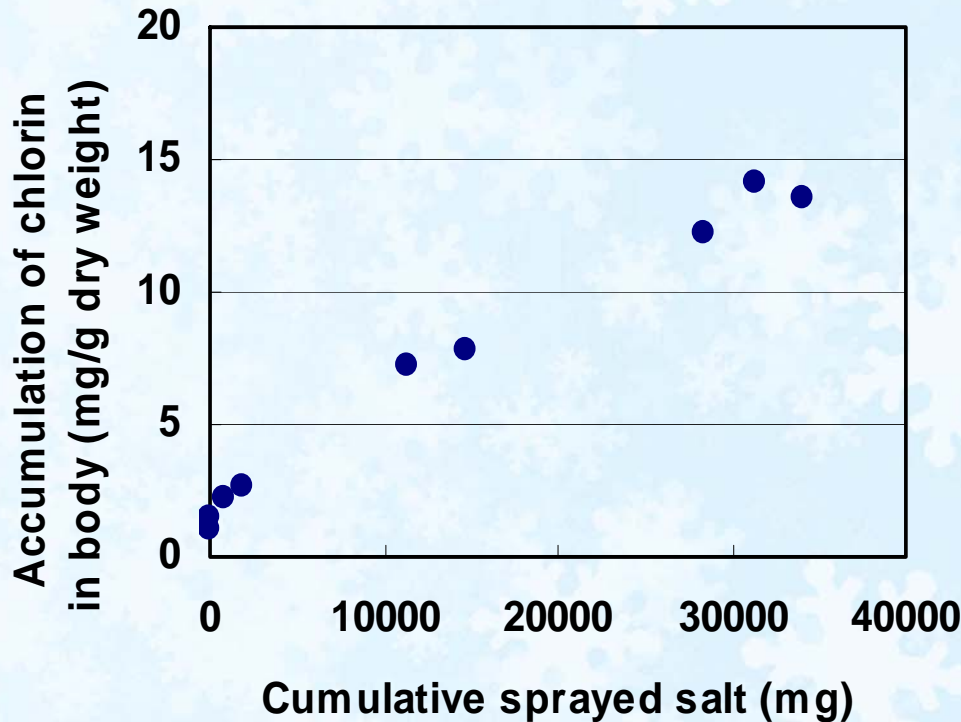
Example of the Relationship of Salt Spread with Salt in Body of Vegetation

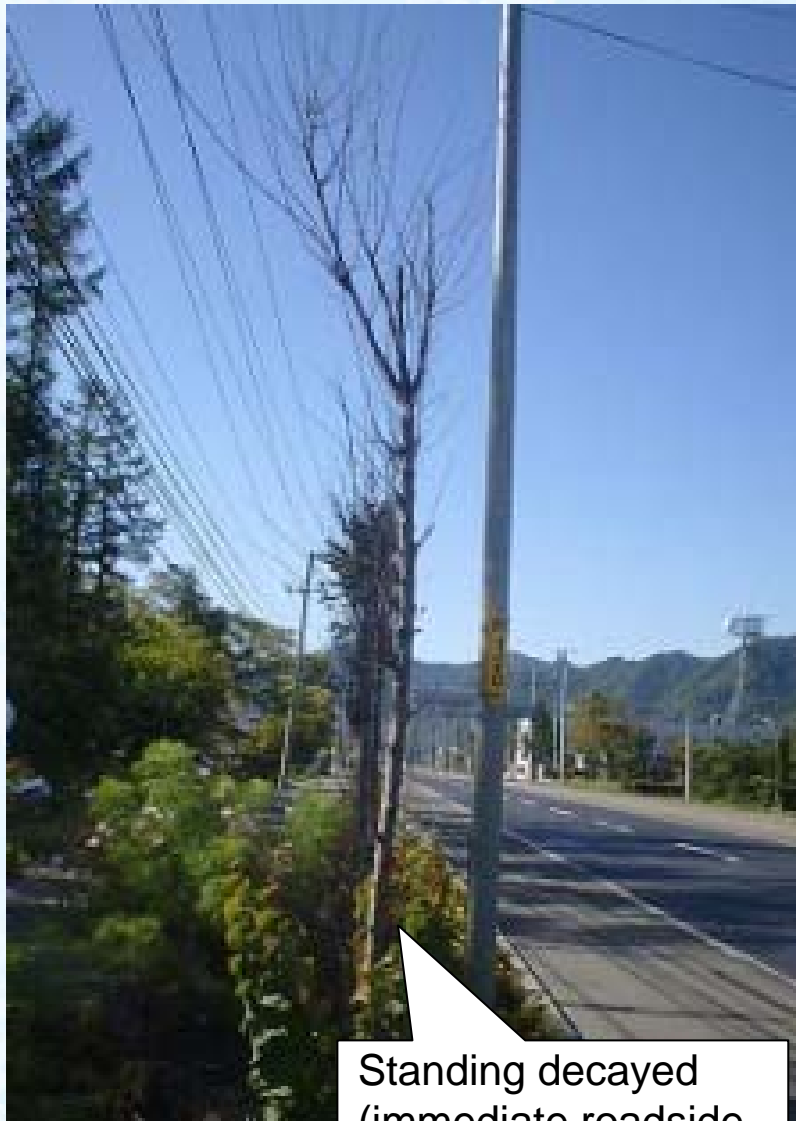
Standing decayed  
(immediate roadside  
has heavy damage)

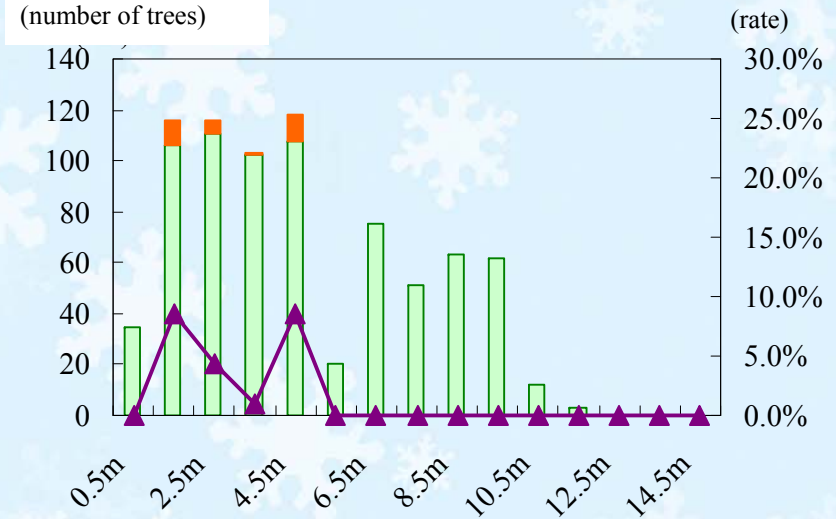
Number and Rate of Trees with Defective Growth (including distance from the road edge)

- The area within 5meters of road edge usually accumulates cleared snow.
- In this area, there are a lot of factors may lead trees to damage or defective growth such as;
  - .the method of afforestation*
  - .the species of tree*
  - .pressure of cleared snow*
  - .collision with a snowplow*
  - .vehicle exhaust emissions etc*
- We think defective growth which were observed are caused by a combination of these factors, the extent of influence on defective growth by de-icing salts is not clear.
