### WINTER OPERATION OF ROAD TUNNELS IN QUÉBEC THE VILLE-MARIE AND LOUIS-HIPPOLYTE-LAFONTAINE TUNNELS

Alexandre Debs, eng., M.Sc.A., MBA Ministère des transports du Québec, Montréal, Canada alexandre.debs@mtq.gouv.qc.ca

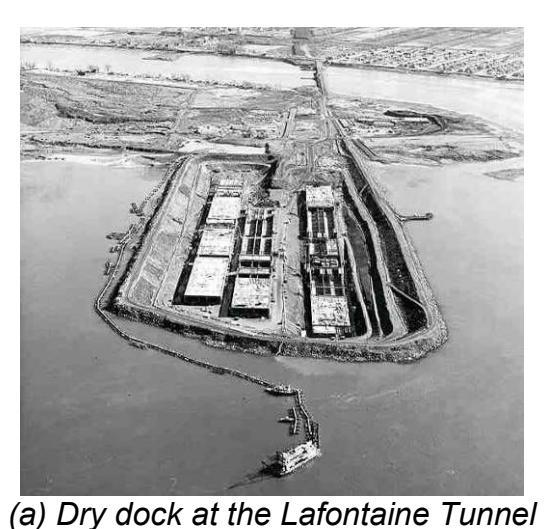
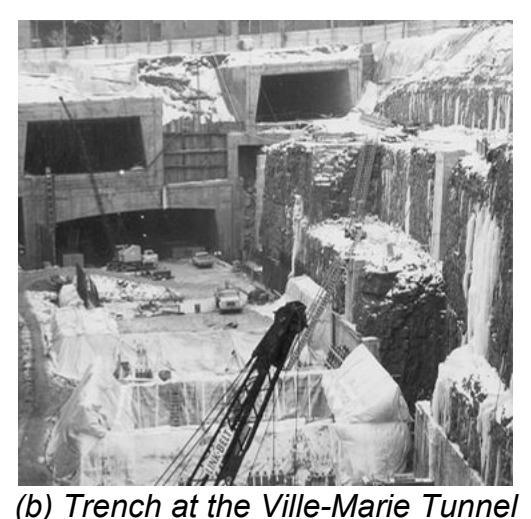
Figure 1. Construction sites for the Lafontaine and Ville-Marie tunnels

The Louis-Hippolyte–Lafontaine tunnel opened in March 1967. It is the older of the two tunnels, and runs beneath the St. Lawrence River. It is a 1.8-km long underwater gallery comprising 7 concrete components that were built in dry dock and then towed, submerged, and assembled on the riverbed. The tunnel consists of two (2) traffic tubes with three lanes each and a central section that is used for services and rescue purposes.

The Ville-Marie Viger tunnel complex is more recent. It is a concrete structure that was constructed in a trench in an ancient riverbed, and subsequently covered over. It entered into operation in several stages: the Ville-Marie tunnel in 1974; the Viger tunnel in 1986; and more recently, three buildings that comprise the Quartier international de Montréal were constructed in 2002 and 2003. The complex now constitutes an underground freeway interchange totalling 6.8 km of traffic tubes varying from one to five traffic lanes, along with several kilometres of evacuation corridors that criss-cross underground Montréal.

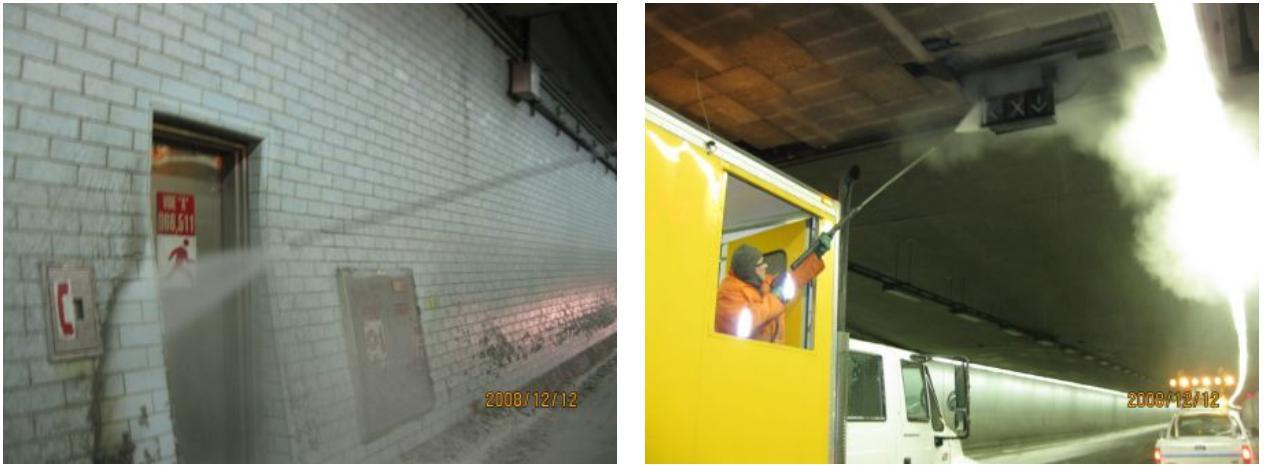
(a) Cleaning the signage

(b) Cleaning lane signals

Figure 2. Cleaning in the Ville-Marie tunnel using a water jet in winter

In winter, these maintenance activities are required at extremely variable intervals. The logistics and intervention methods required are quite different from those during the summer. For example, wall cleaning cannot be carried out using a brush-truck, because these vehicles are taken off the road from December to March. When there is a warm spell, the walls, the signage, and the traffic signals are cleaned manually or using a water jet (Figure 2).

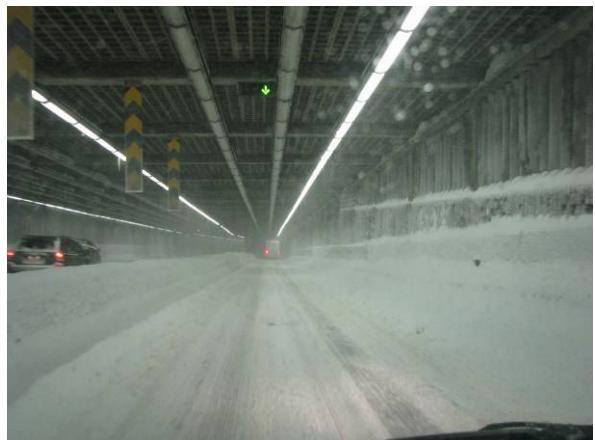
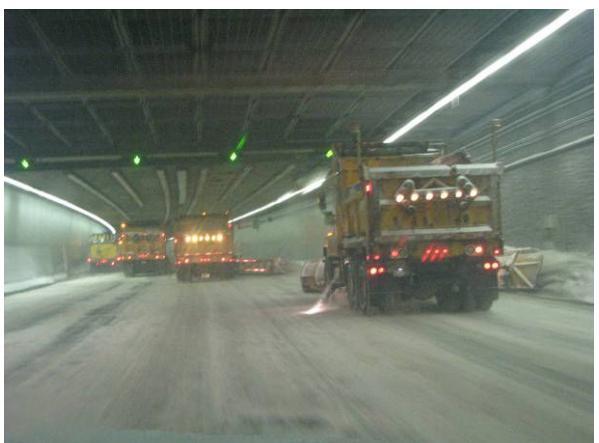
(a) Accumulation of snow at the portal
(b) Snow and ice removal inside a tunnel
Figure 3. Winter maintenance in the Ville-Marie tunnel

maximum tolerance of 5 to 7 cm of snow. Traffic lanes must be completely cleared within 3 to 5 hours after the end of the precipitation event. Tunnel entrances and exits are critical areas that require special attention (Figure 3). When precipitation is heavy, these zones represent areas of sudden change in terms of both visibility and road surface conditions (snow accumulation). In light of this, these areas receive particular attention in terms of snow removal and salt spreading. The use of abrasives (e.g.: sand) is no longer allowed inside tunnels. Experience has shown that sand blocks the drainage system and impacts the visibility inside tunnels and through the cameras, which affects user safety.

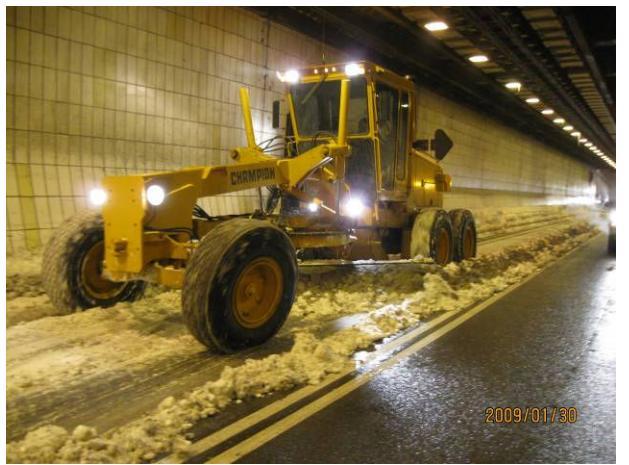
(a) Accumulation of snow at the entrance

Figure 4. Winter maintenance in the Louis-Hippolyte–Lafontaine tunnel

Removal and hauling of snow at tunnel portals is carried out after the storm, and requires the complete closure of the tunnel. This operation has a substantial impact on the free traffic flow of the Metropolitan area and is carried during the night on the day after a storm (Figure 4). It involves picking up the snow that has accumulated at the entrances, because tunnels do not have any space to contain the accumulation of snow at the portals. With this in mind, it would be quite beneficial to plan for such a space at entrances during the design stage for tunnels in northern environments.

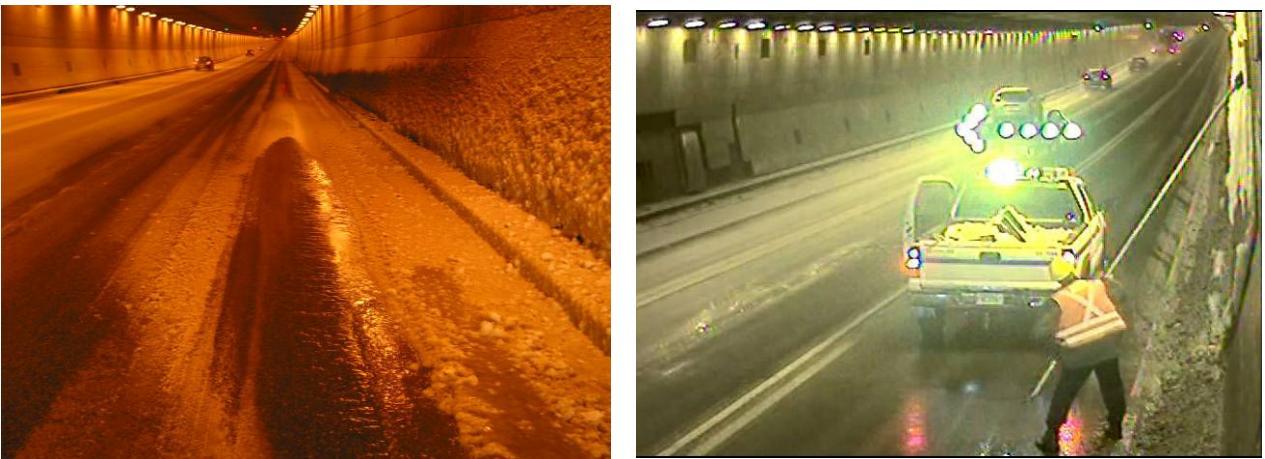
(a) Ice patches on pavement

(b) Removal of icicles

Figure 5. Formation and removal of ice in tunnels

Finally, monitoring and removal of icicles and ice patches resulting from infiltrations is an operation that is carried out on a continuous basis, governed by clearly defined intervention criteria. The Louis-Hippolyte–Lafontaine tunnel is inspected at 1:00 a.m. and 1:00 p.m. every day. In order to facilitate this inspection to ensure the absence of icicles,

one or two lanes are blocked in mobile roadwork mode. There is only one daily inspection At the Ville-Marie Viger tunnel, at 1:00 a.m. If icicles or ice patches on the pavement are detected, a team is mobilized in order to intervene as soon as possible and ideally before the morning rush hour, which starts around 5:00 a.m., or the evening rush hour, which starts around 3:30 p.m. This urgent intervention often has a major impact on traffic. However, "operation icicles" is widely known and well understood by both the media and the public.

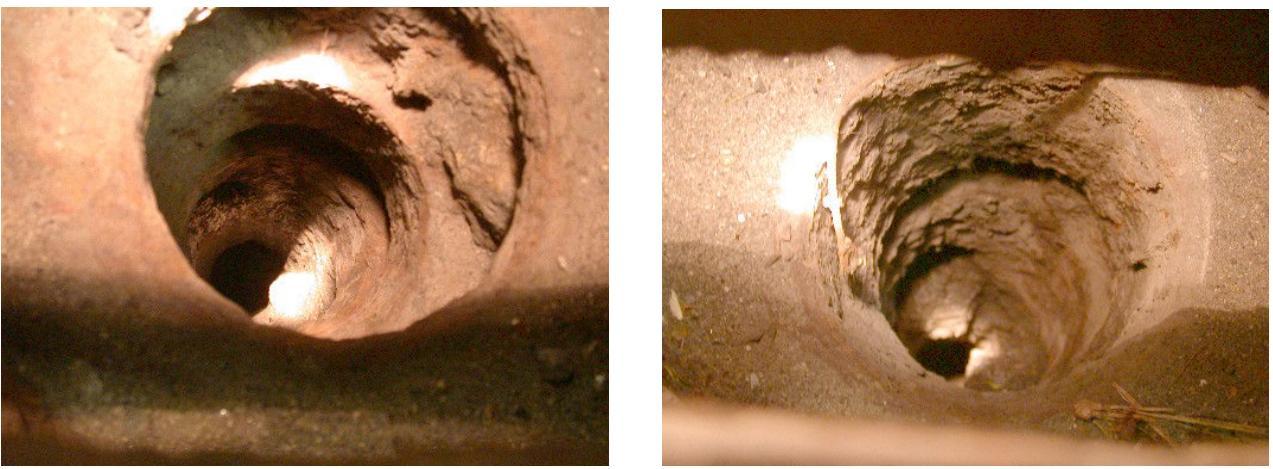
(a) 55% blocked drain (b) 97% blocked drain Figure 6. Sediment adhering to the walls of drainage pipes

A 2005 inspection of the drainage system for the Ville-Marie tunnel revealed that many of its pipes were blocked. This blockage ranged from 15% to 97% in the 150 mm pipes (Figure 6). Stagnant water mixing with accumulated sediment creates a sludge that ultimately hardens and blocks the drains.

A study of samples taken from these deposits reveals that the obstructions consist of 64% calcium carbonate and 19% silica. These deposits are generated by a chemical reaction that releases minerals from the water when exposed to heat from the heating cables. The presence of silica explains the hardness of the deposits on the drain walls, and why it is so difficult to remove these deposits using conventional methods.

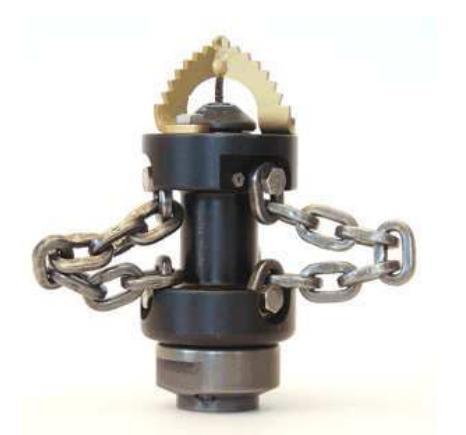
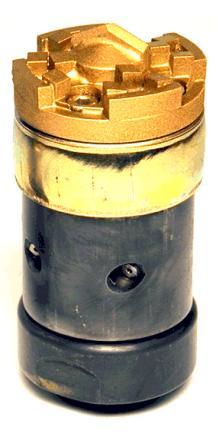
(a) Reaming Nozzle with Chain Head (b) Reaming Nozzle with Cutting Head Figure 7. Selected Reaming Technique

As the tunnels have aged, annual maintenance using pressurized water trucks (up to 20,000 kPa of pressure) was no longer sufficient to clear these deposits and keep the drainage system working. The magnitude of the obstructions suggested that, if a method were found to restore the design hydraulic pressure in the tunnel, much of the leakage would be adsorbed, and the formation of icicles would be eliminated. A non-structural reaming process was used to rehabilitate the drains in the Ville-Marie tunnel following tests on a few drains that yielded conclusive results (Figure 7).

The selected reaming technique employs heads that are driven longitudinally and vertically by water. The longitudinal jet of water propels the head forward, while the transverse jet propels it at an angle, producing rotation that enables the teeth to dislodge deposits and enables the chains (Figure 7a) to deploy radially in order to restore the initial diameter of the drain. In the case of harder deposits, such as concrete residues that have set, a reaming nozzle with a cutting head (Figure 7b) is used to bore a passage in the appropriate pipe. Once the passage has been bored, the reaming nozzle with the chain head is used to remove the deposits from the walls. Reaming time varies considerably from one pipe to another, depending on the length of the pipe, the percentage of obstruction, and the hardness of deposits. An inspection camera is vital for determining the type of obstruction and selecting the appropriate head.
